MARCH, 7TH-11TH 2016

IN LEBANON

RESTORATION AND SEISMIC RETROFIT OF "VILLA GUARRACINO". TORRE ANNUNZIATA, NAPLES

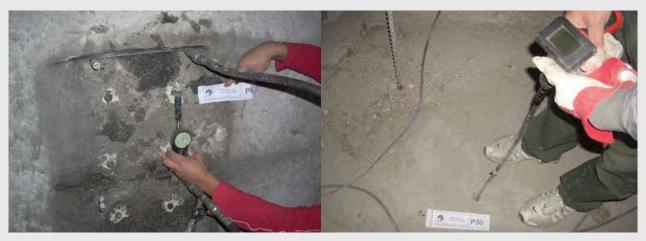
On-site test: Endoscopy
