quaderni di assorestauro

YEAR05NR01  
MARCH 2016

## WORKSHOP ICE-ASSORESTAURO LEBANON 2016

## TRAINING WORKSHOP SEMINARS & COMMERCIAL MEETINGS IN LEBANON

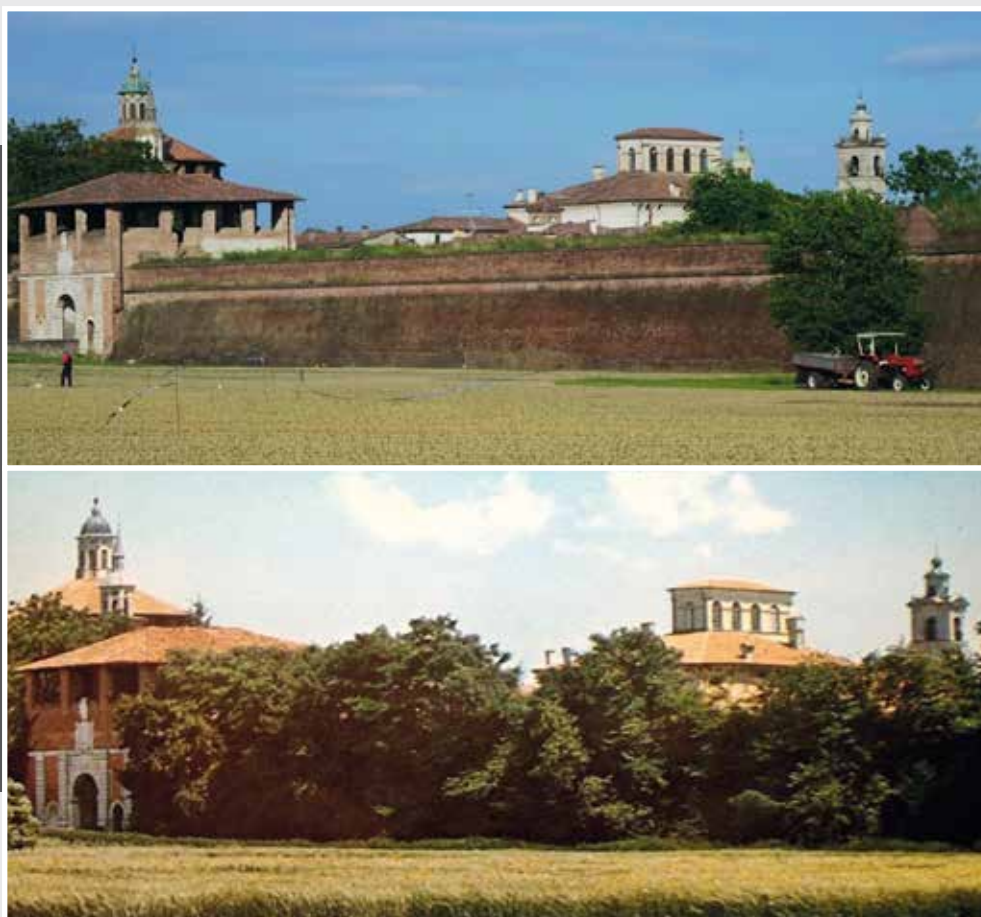
The city walls of Sabbioneta: present state and situation in 1985. The walls were built within 3 campaigns (1556-67, 1578-79, 1584-1600) in the shape of an irregular hexagon. They were abandoned for centuries and restored since 1994  
(Photo D. Del Curto/Private collection)

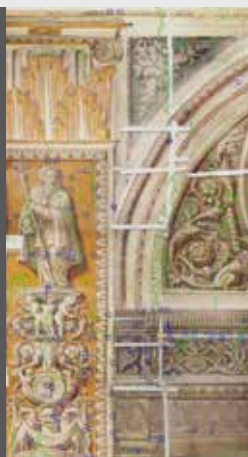
**St. Andrew's Basilica in Mantua: decay mapping in the pilot-yard**  
(Photo and drawing D. Del Curto)

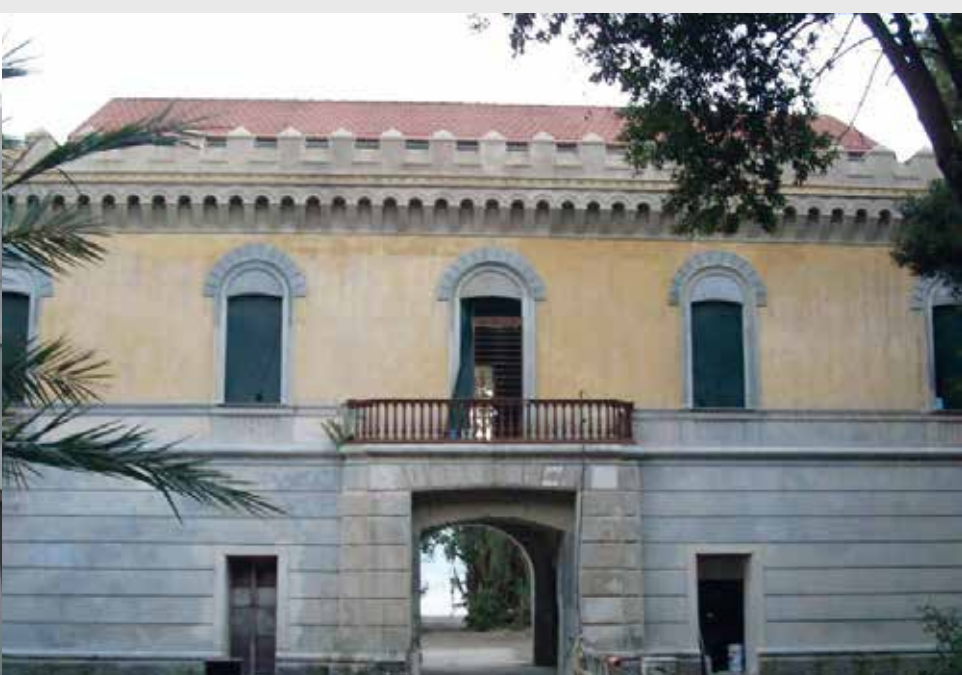
On-site test with Double Flat Jacks

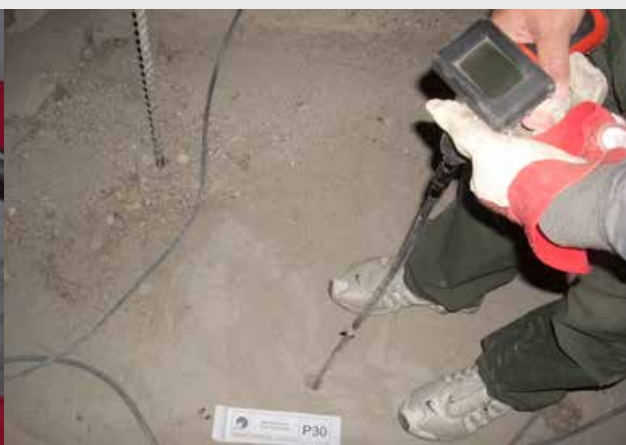
On-site test: Endoscopy

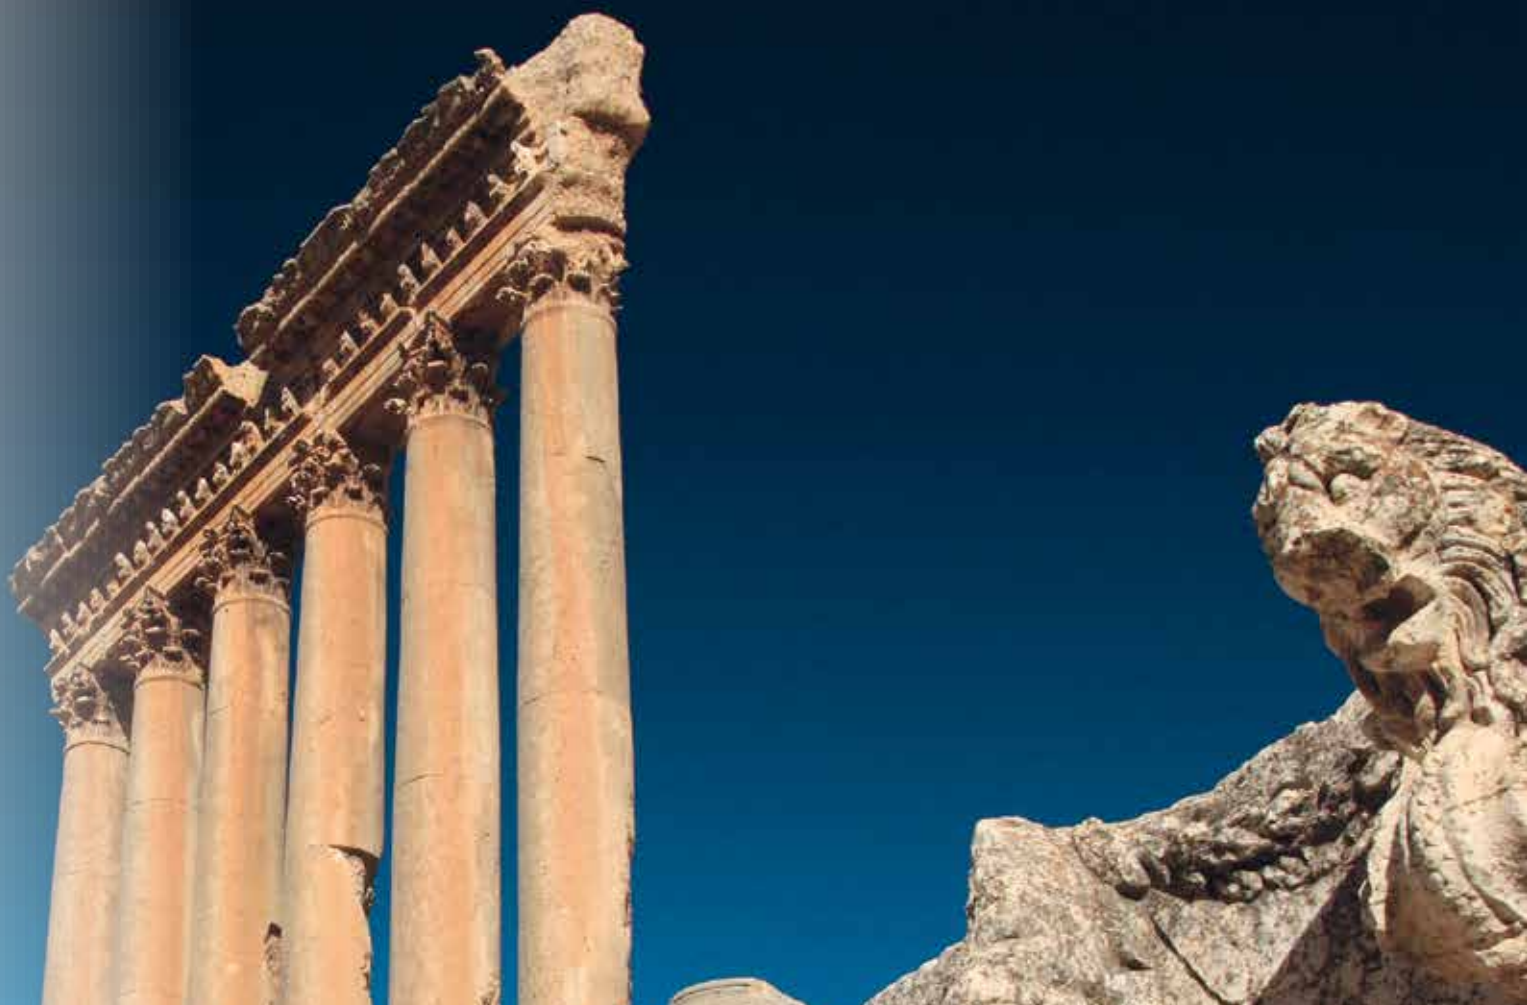
## 2 - BACCHUS TEMPLE Mapping of surface degradation

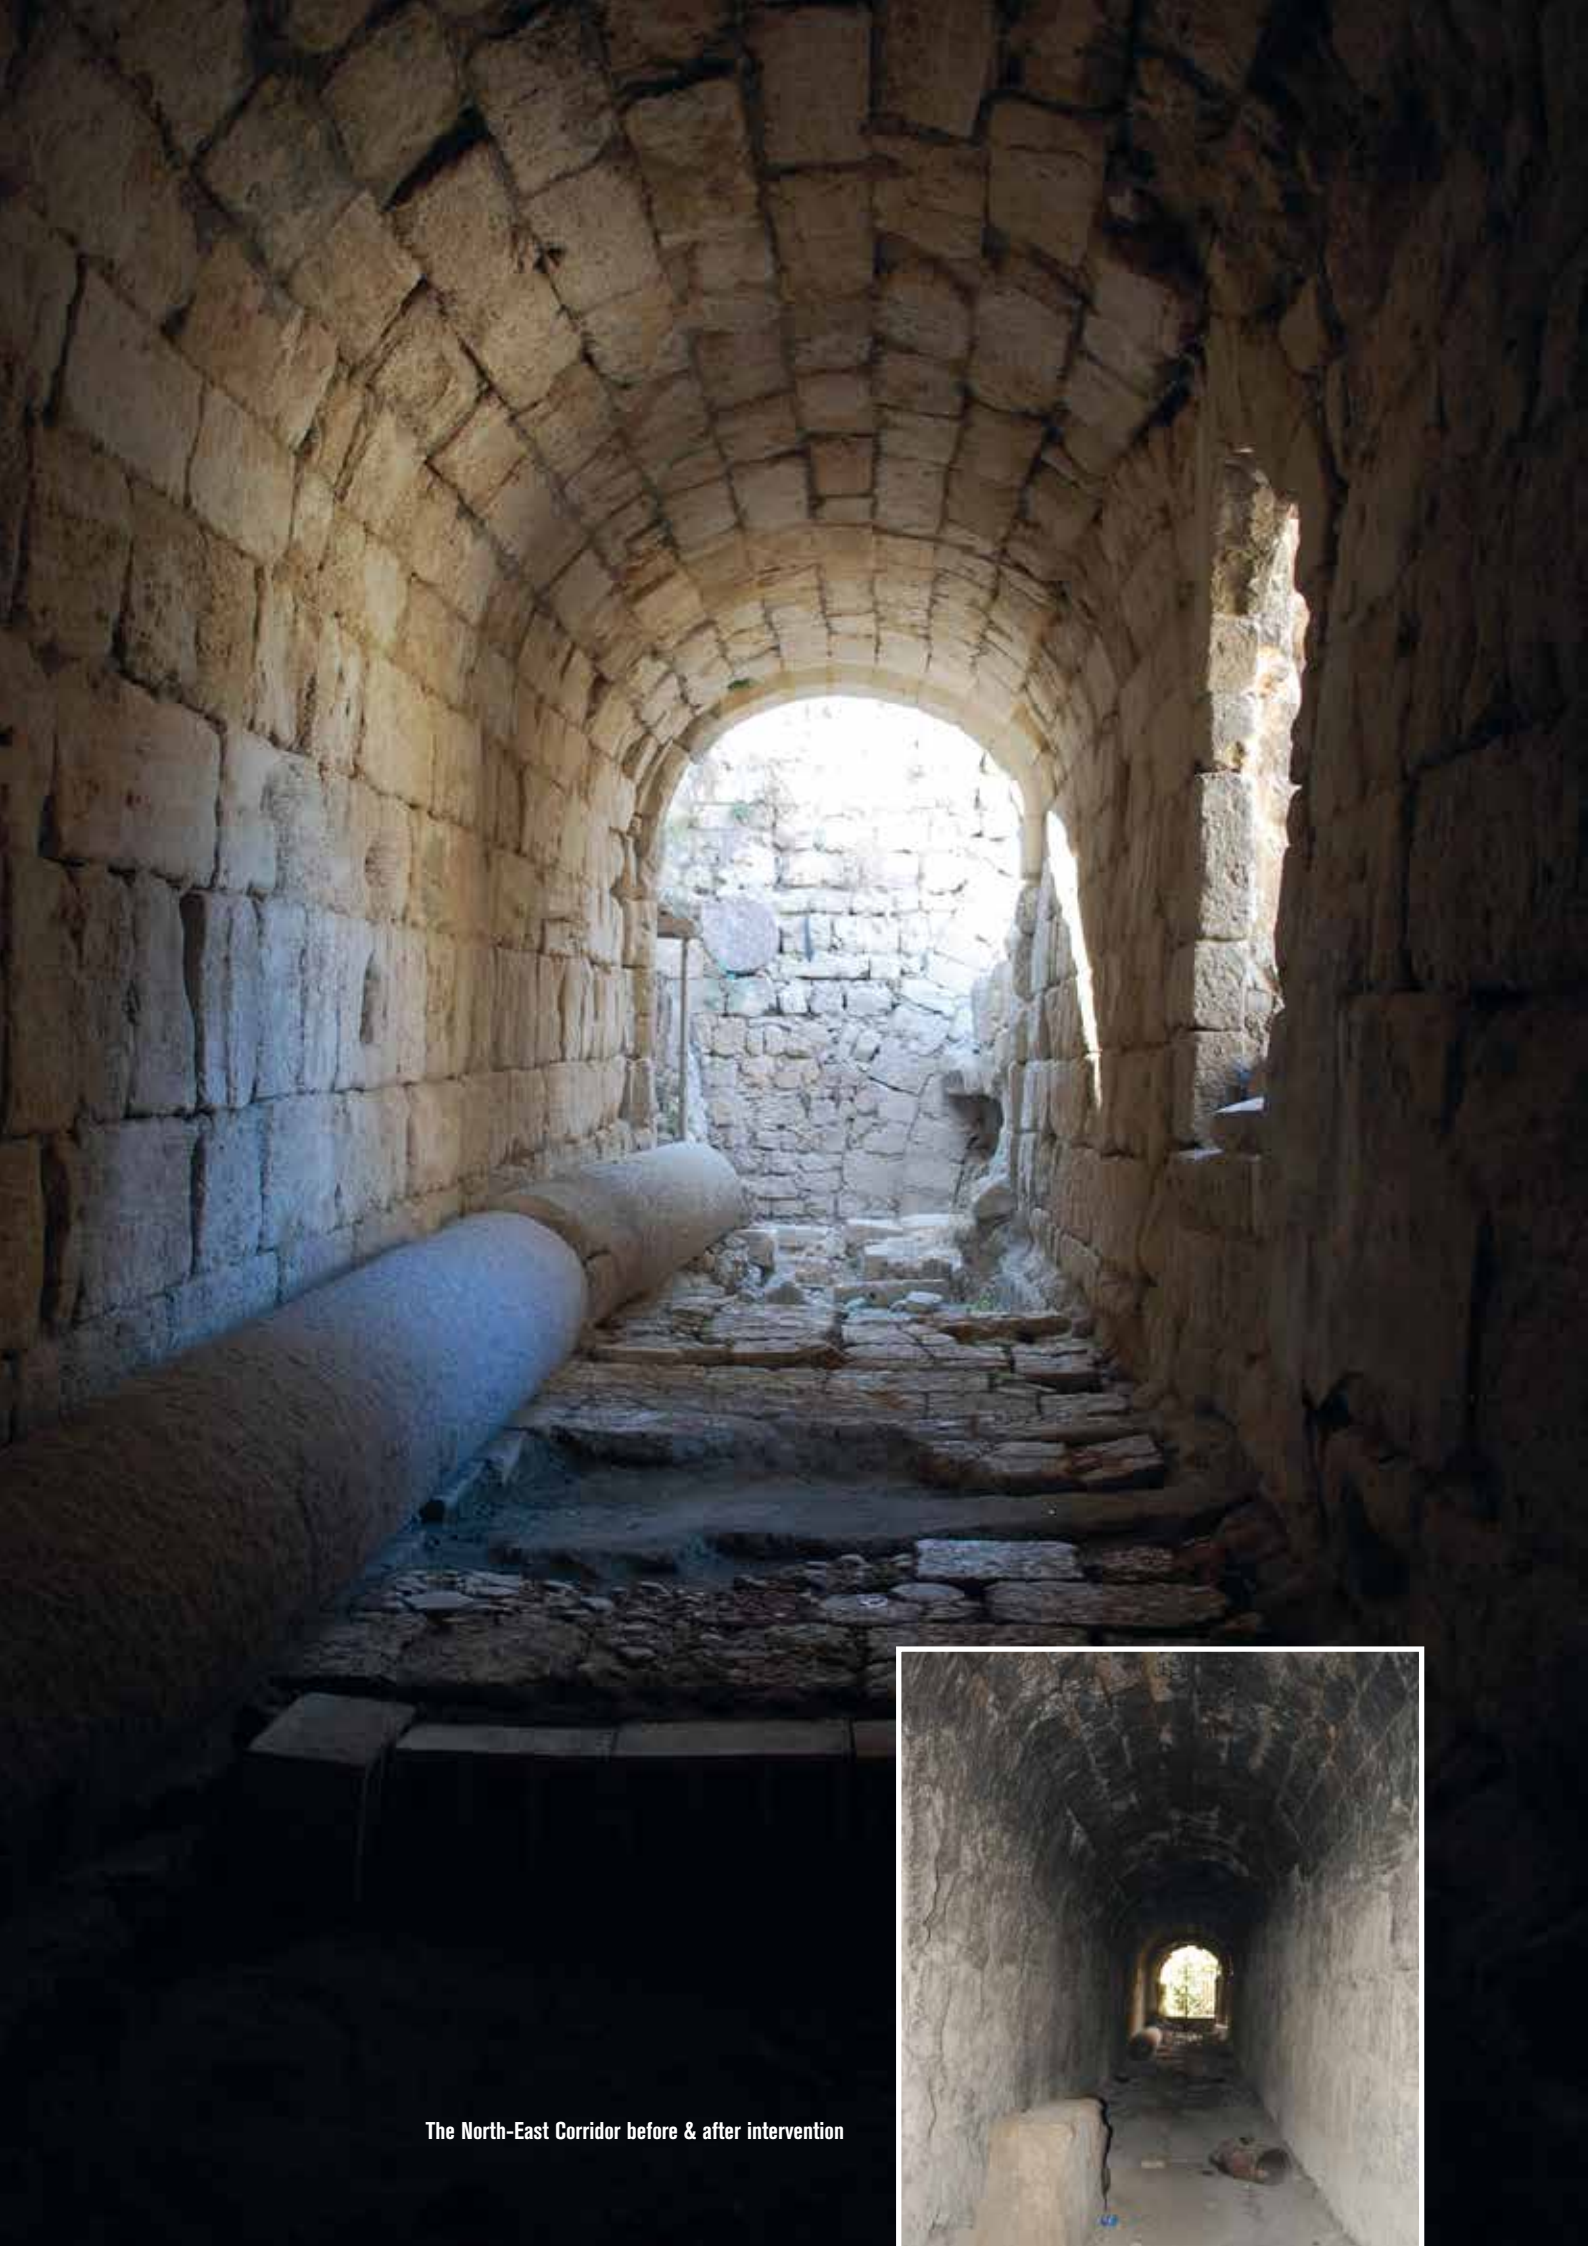
The North-East Corridor before & after intervention

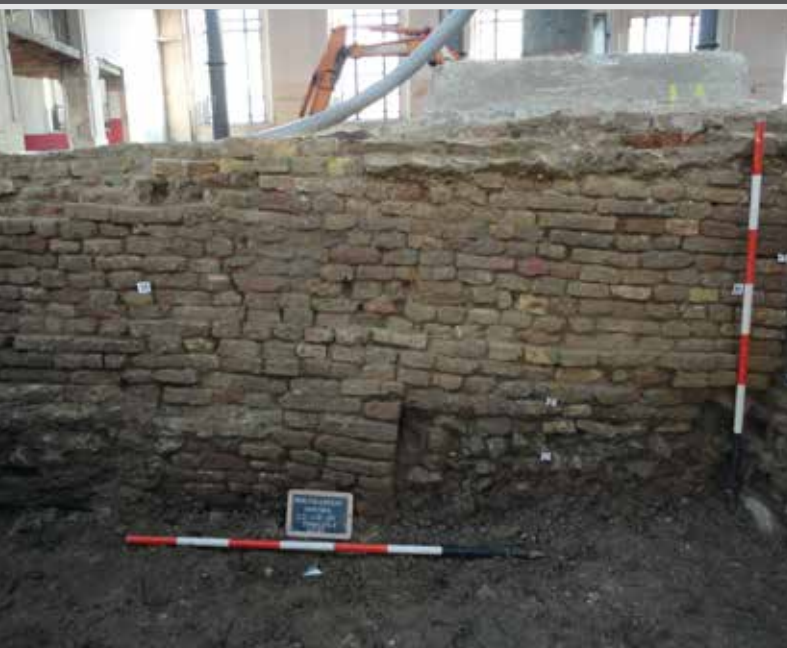
Line of imposing wall with direction North-south recovered in the trench E. This wall should probably belong to the more ancient building phase of the area. From the image the stratigraphy is clearly seen by the tall one to the lower part; the native bricks floor of the Mercato Coperto that it leans on the crest of the most ancient wall and on the right another wall of following phase with the relative foundation

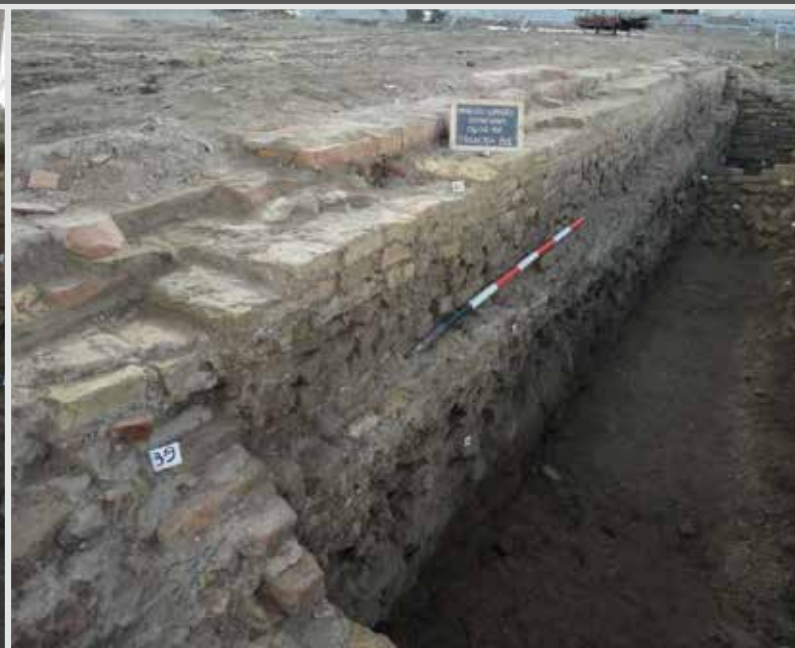
Long stretch of wall with course North-south with different constructive phases recovered in the trench B. We well notice the small transversal walls that divided the environments inside the buildings.

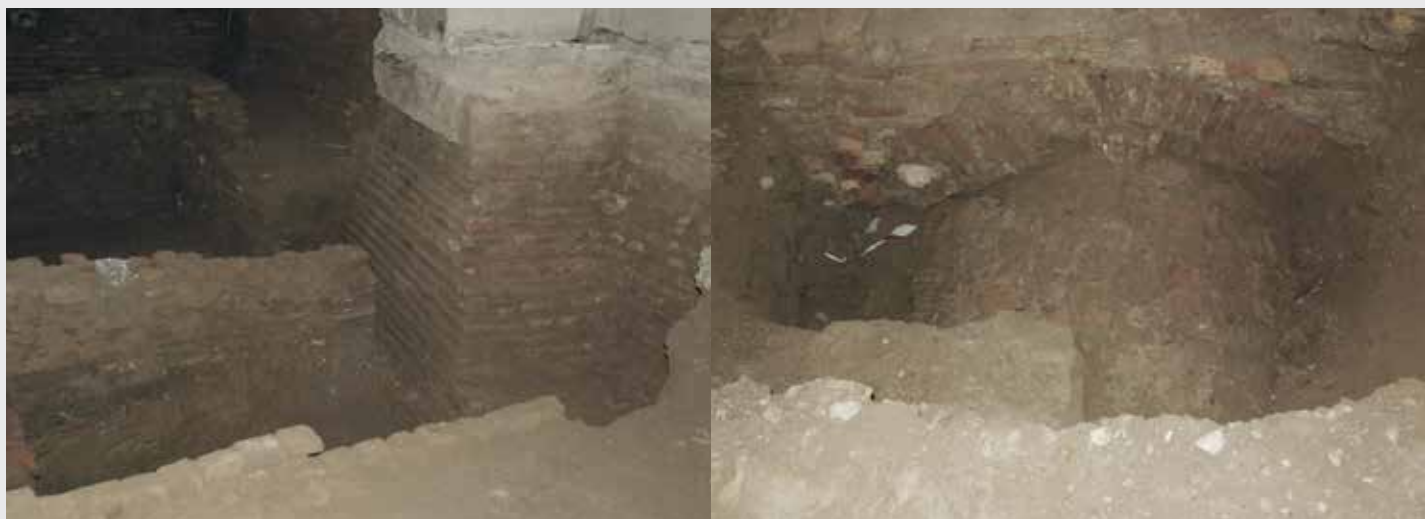
Particular of the trench B that well visualizes well the different building phases in the centuries of these structures

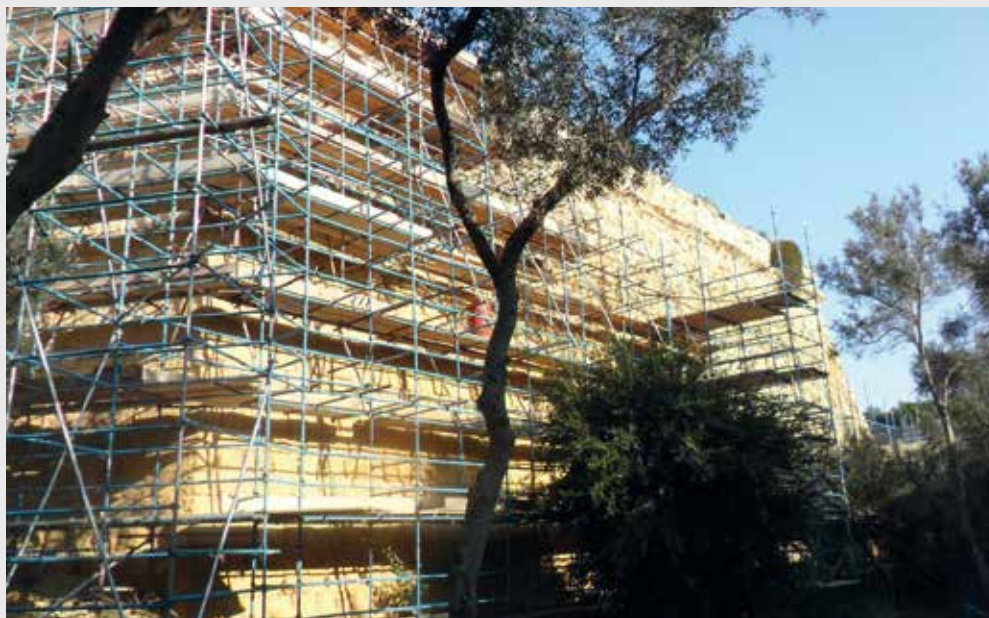
Mechanical Damage

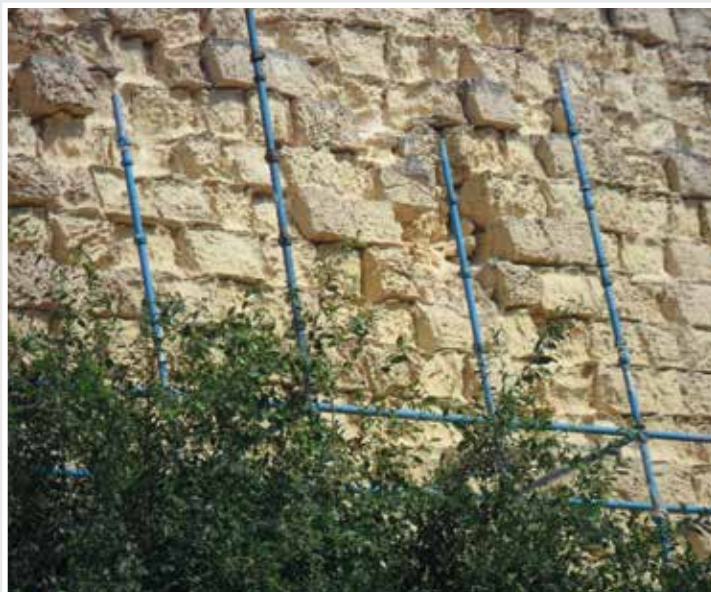
Pitting of the surface

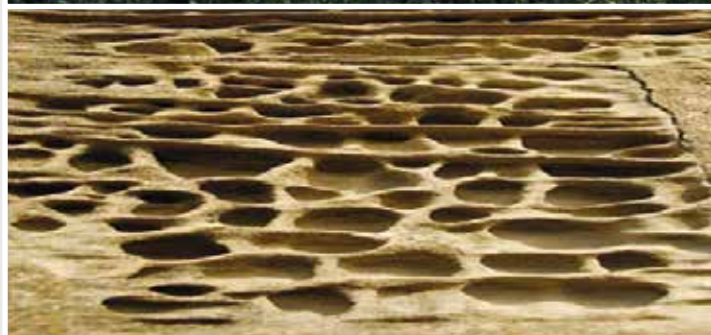
Biological infiltrations

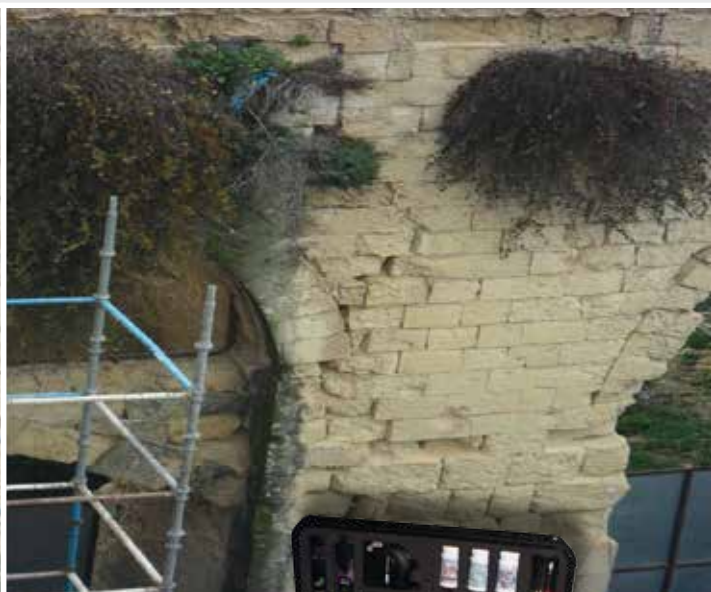
IBIX Mobile Lab

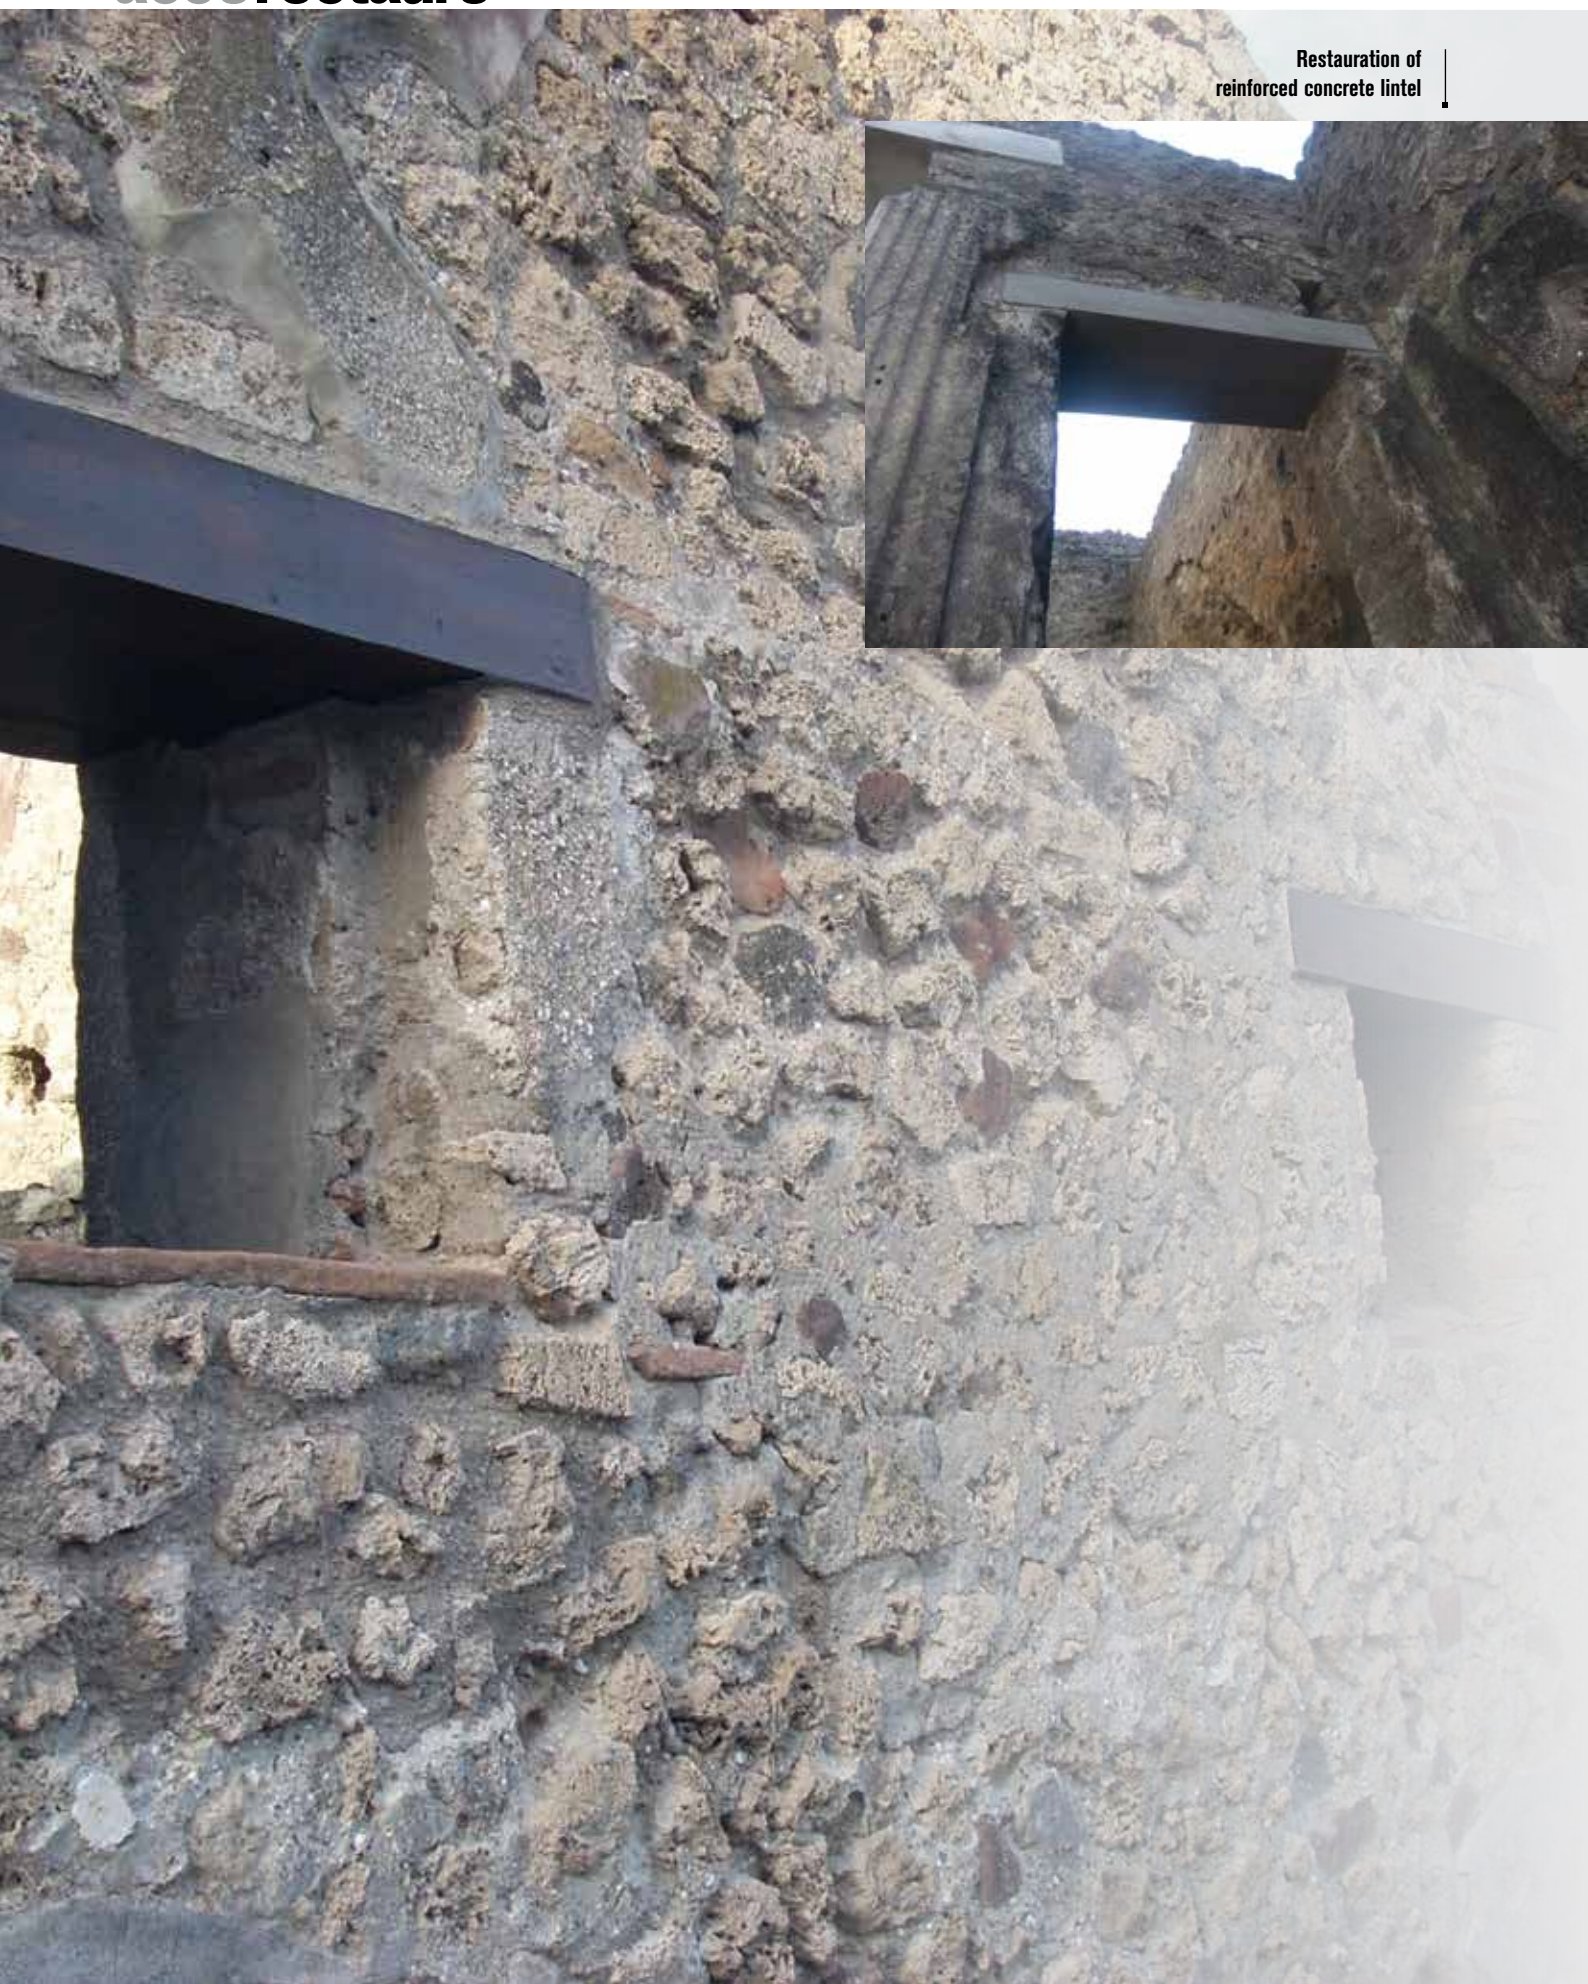
Cover with  
sheet Coverib
